Manhole Inspection Summary

Manhole # S41AA_043MH

Insp Date: **11/28/07 2:00 PM**

Location Address: **e.monument st**

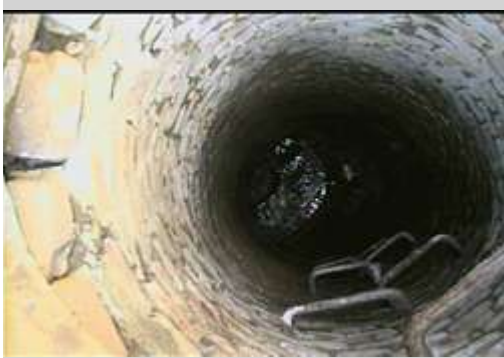
Defect 1

Condition: ☐ Sound ☐ Cracked ☐ Root Intrusion ☒ **Loose Brick** ☒ **Deteriorated**

Count: **10** Missing: **0** ☒ **Corroded**

☒ **Evidence Of Surcharge**

corbel is cracked & deteriorated with loose bricks; corroded steps; surcharge evidence

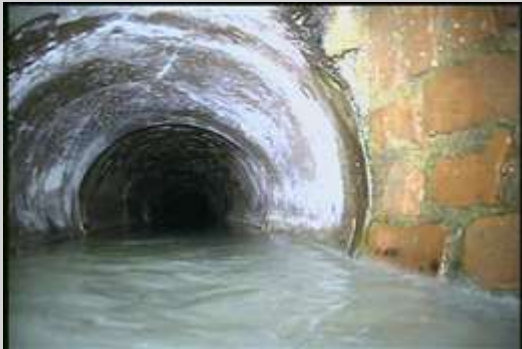
12 O'Clock Outflow

18 in. Circular Gravity Sewer
Pipe Out @ 12 O'Clock

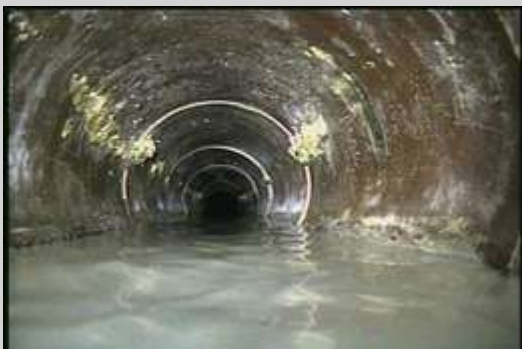
3 O'Clock Inflow

18 in. Circular Gravity Sewer
Pipe In @ 3 O'Clock

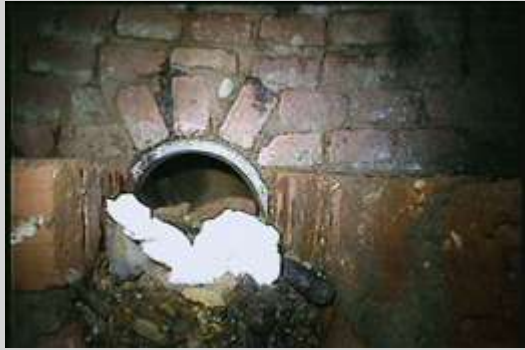
6 O'Clock Inflow

8 in. Circular Gravity Sewer
Pipe In @ 6 O'Clock

Deposits: ☐ None ☐ Mud ☐ Sludge ☒ **Debris** ☐ Grease

Silt Depth: **3** (in.) Deposits Extent: **Medium**
